Chapter 4

Environmental Overview

SARATOGA
COUNTY
AIRPORT

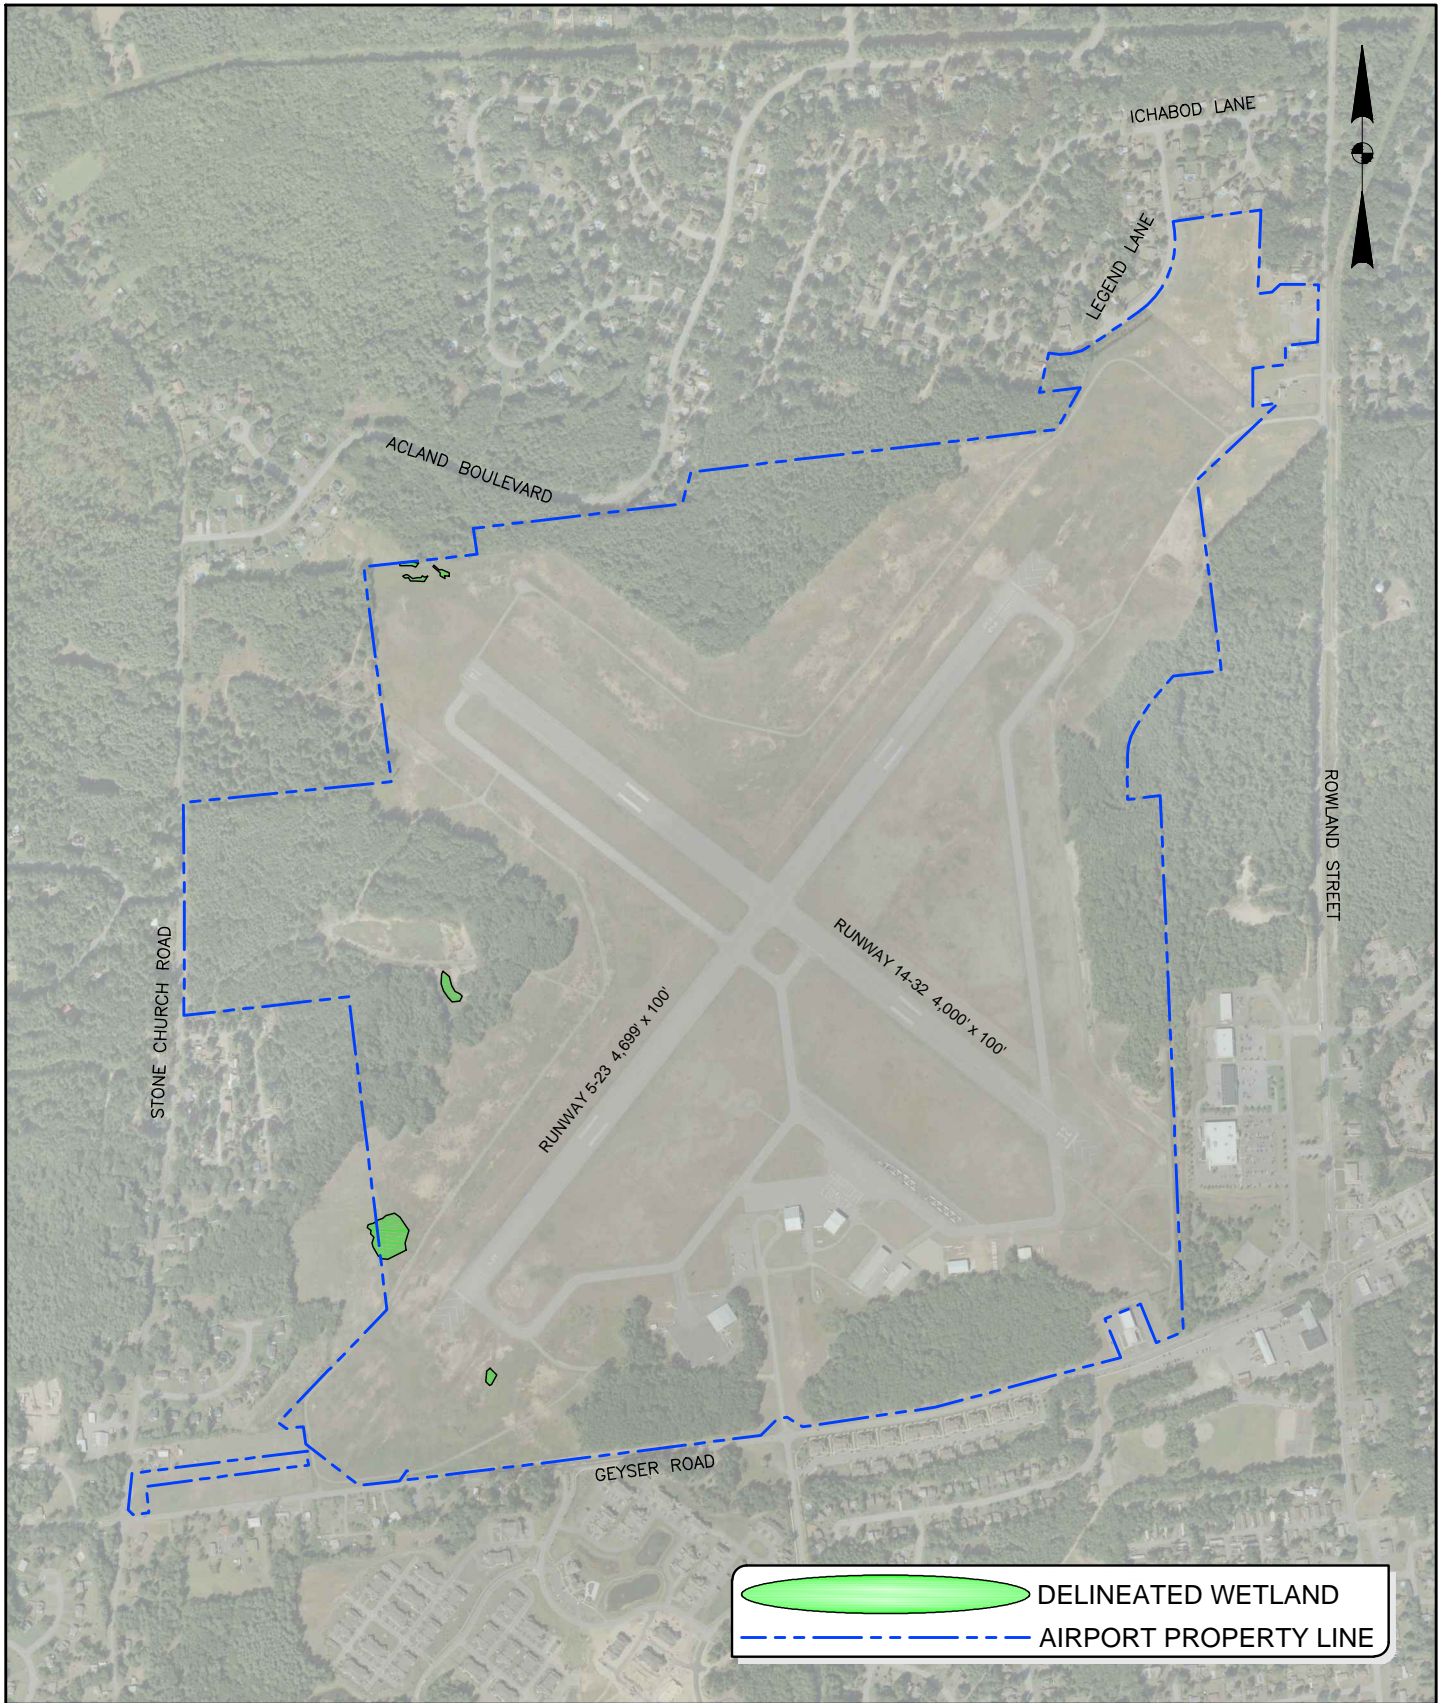
FIGURE 4-7

DELINEATED WETLANDS

Depending on the State and Federal jurisdictional statuses of the identified wetlands, projects that have no practicable alternatives to avoid direct impacts to wetlands may require Section 404 permits from USACE and/or Article 24 permits from the NYSDEC. Impacts to NYSDEC regulated wetlands 100 feet adjacent areas would also require an Article 24 permit from the NYSDEC. The USACE issues activity specific Nationwide Permits (NWP), for wetland disturbances meeting specific conditions. If a proposed project does not meet the conditions of any of the Nationwide Permits, a USACE Individual Permit is required before any work that causes disturbance in or near protected wetlands can commence.

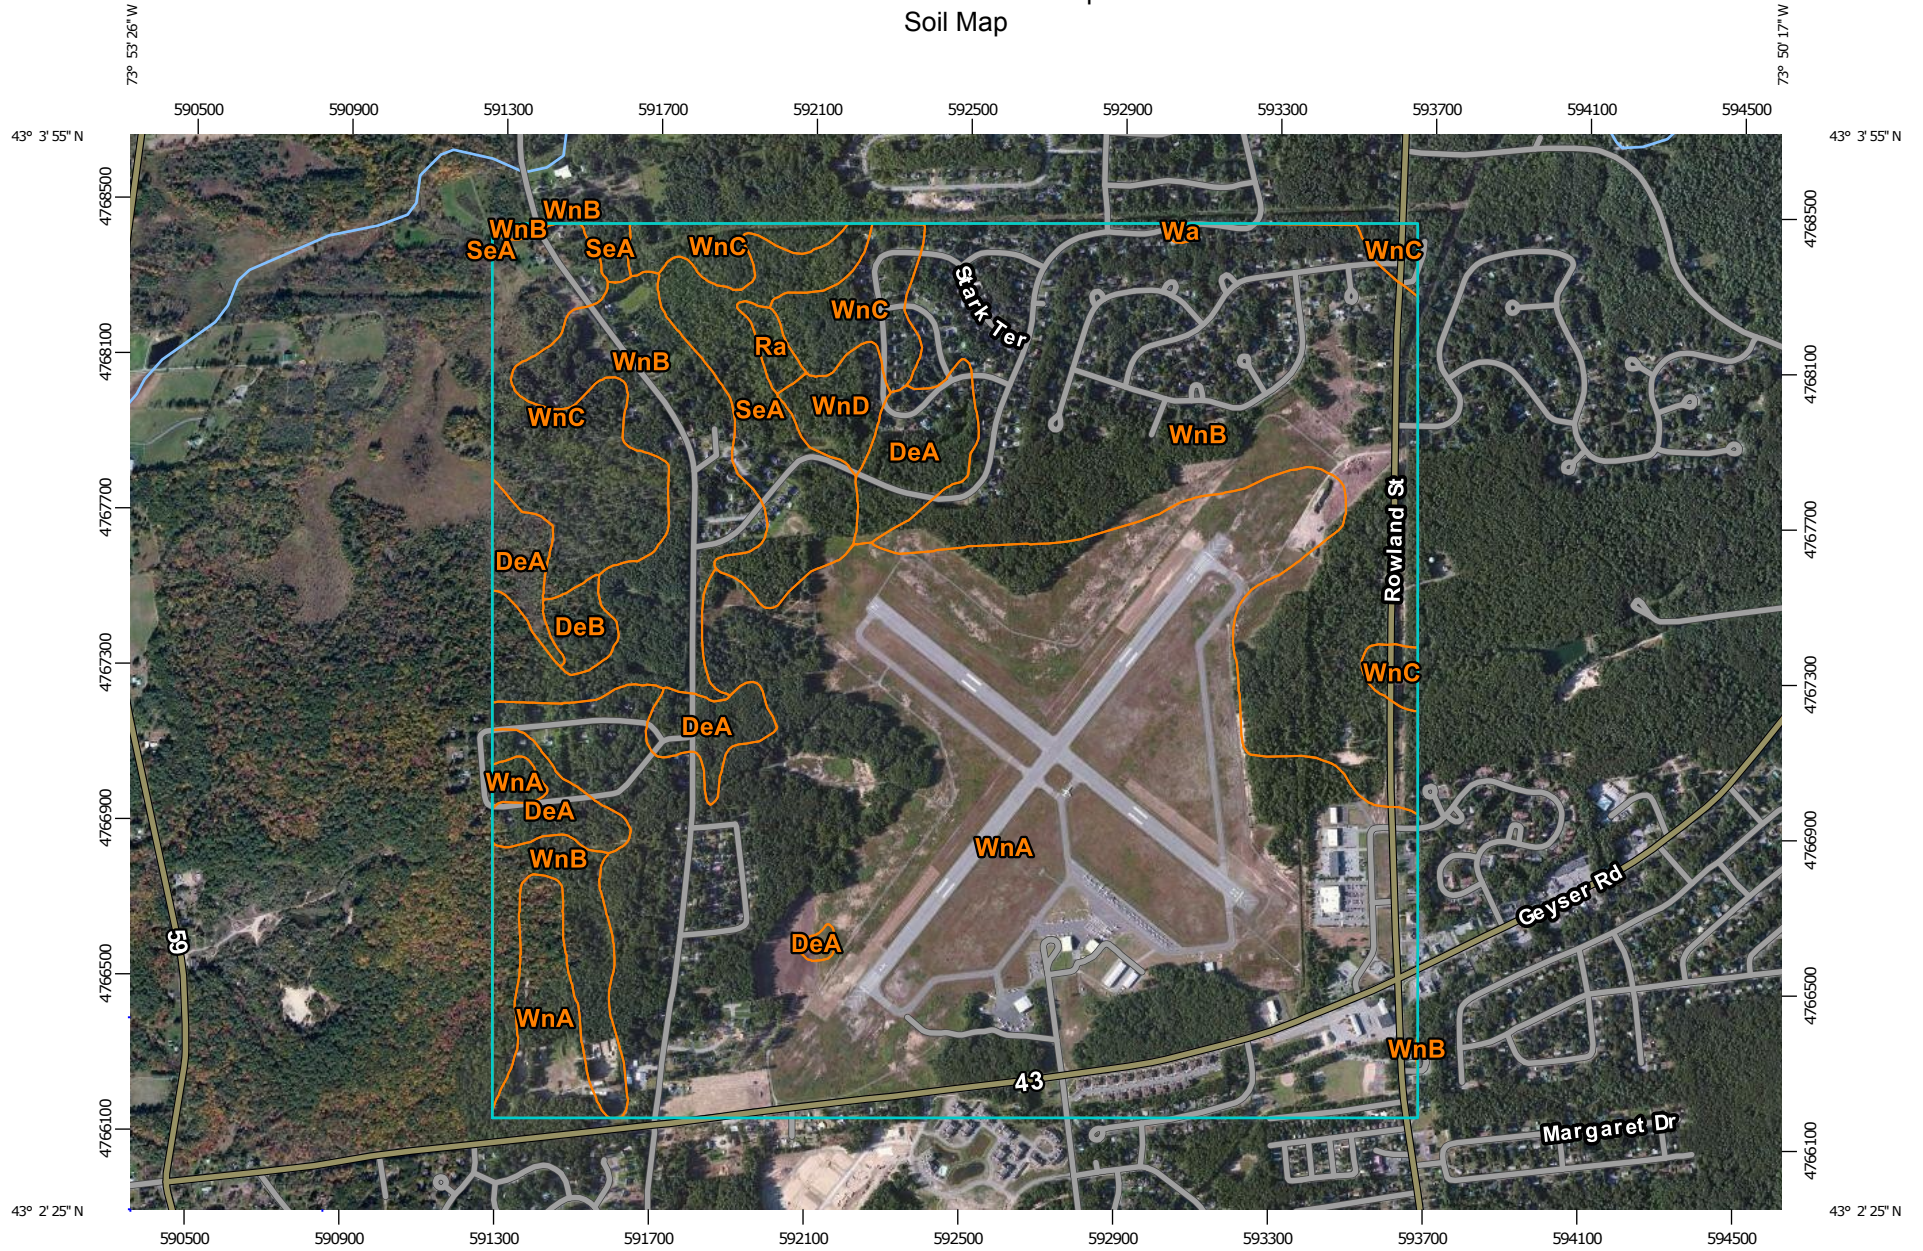
The soil map section includes the soil map for the defined area of interest, a list of soil map units on the map and extent of each map unit, and cartographic symbols displayed on the map. Also presented are various metadata about data used to produce the map, and a description of each soil map unit.

Custom Soil Resource Report Soil Map

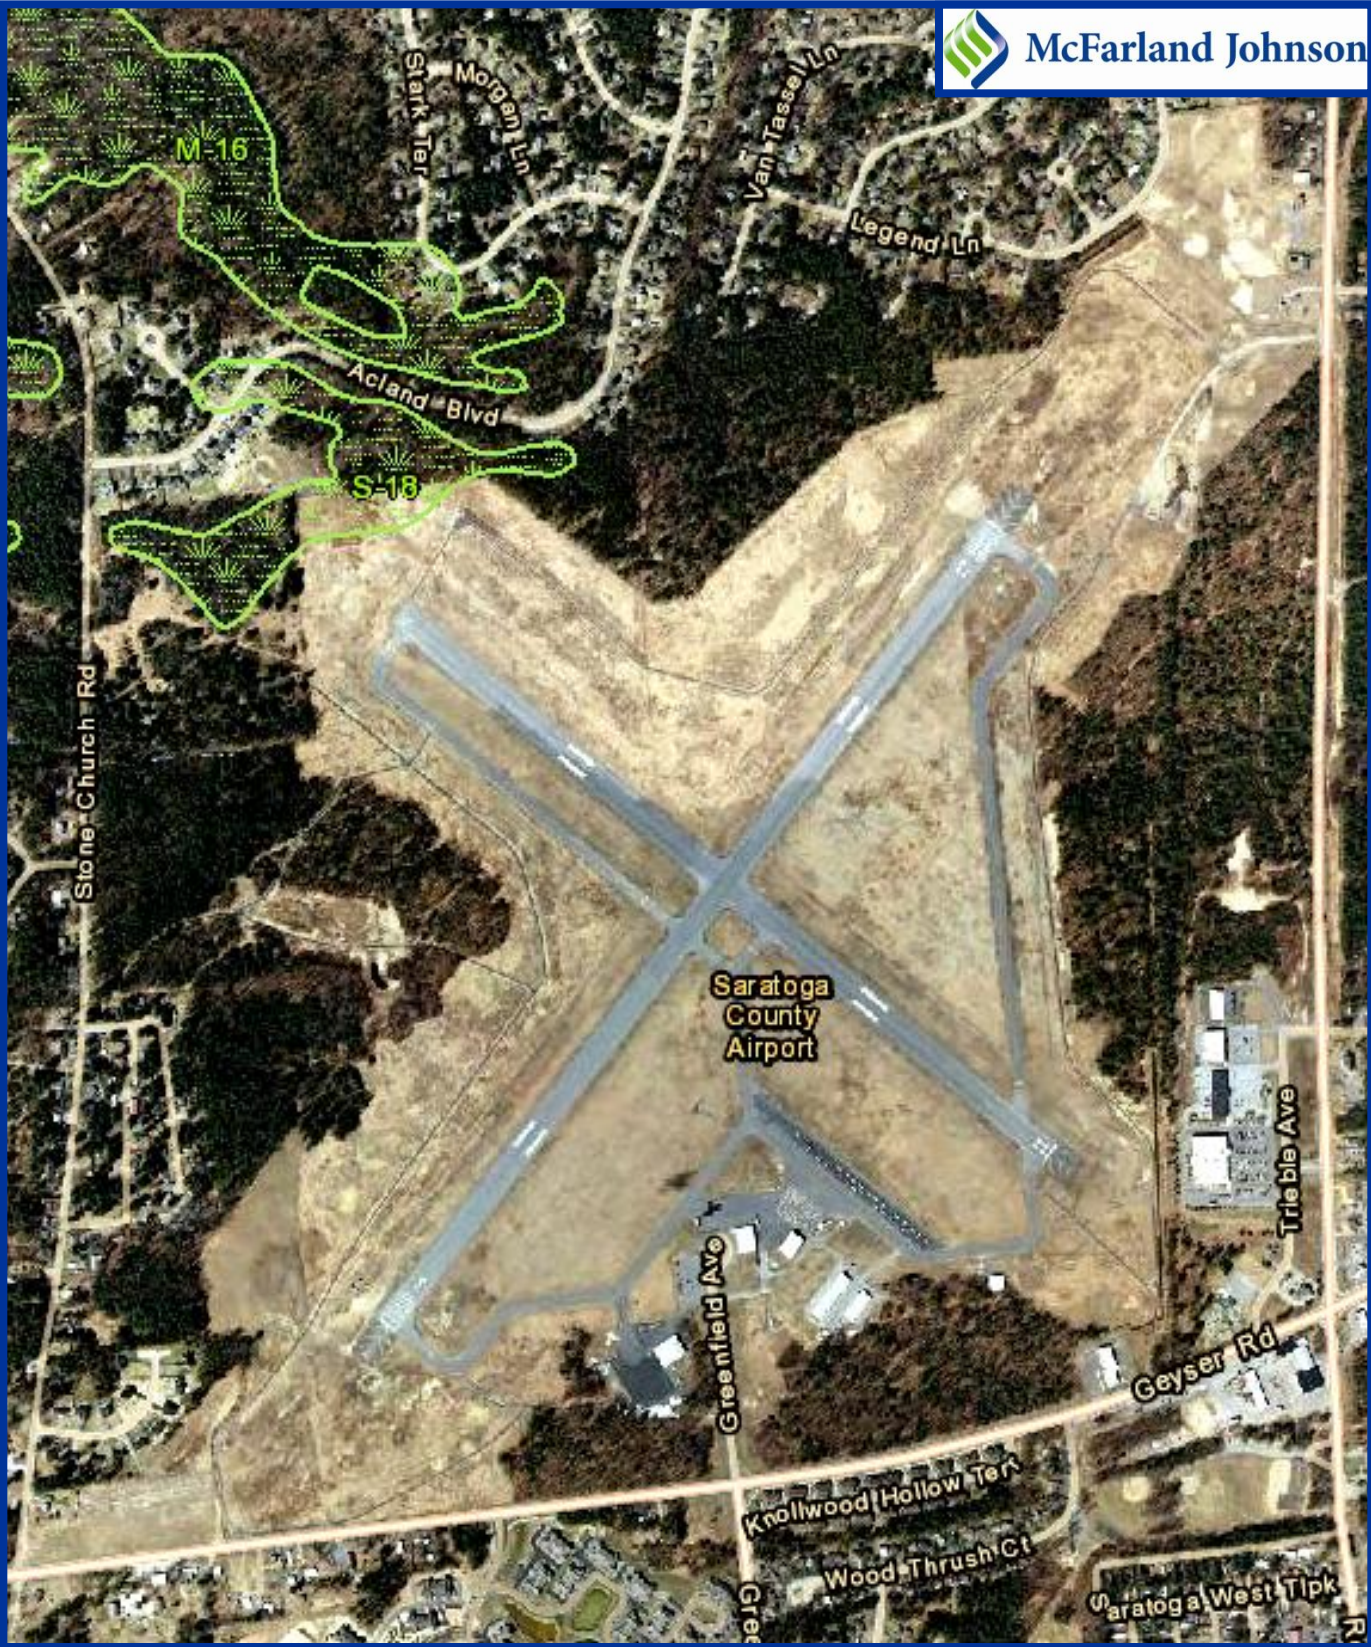
Figure 2

**NYSDEC Freshwater Wetlands Map
Saratoga County Airport
Ballston Spa, Saratoga County, New York**

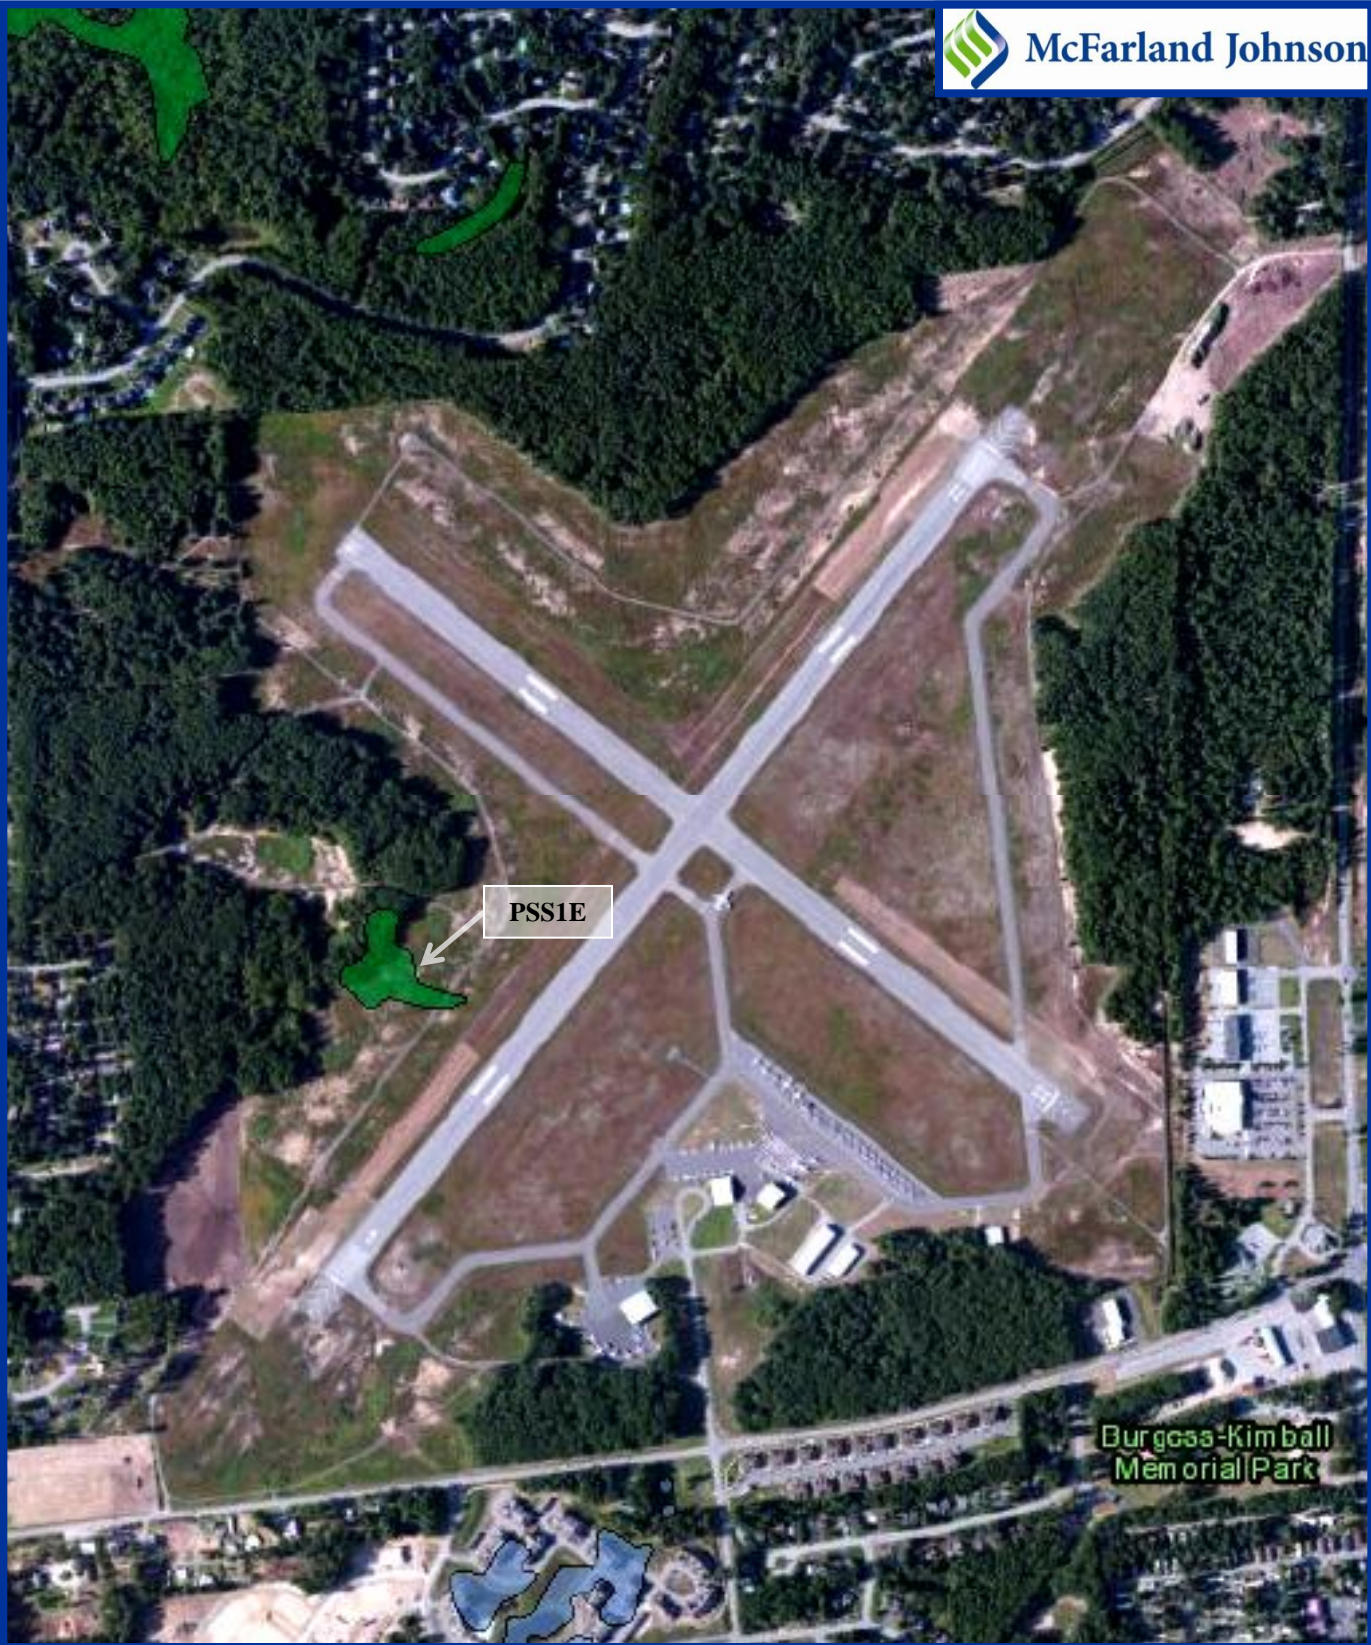
Figure 3

NWI Wetlands Map
Saratoga County Airport
Ballston Spa, Saratoga County, New York

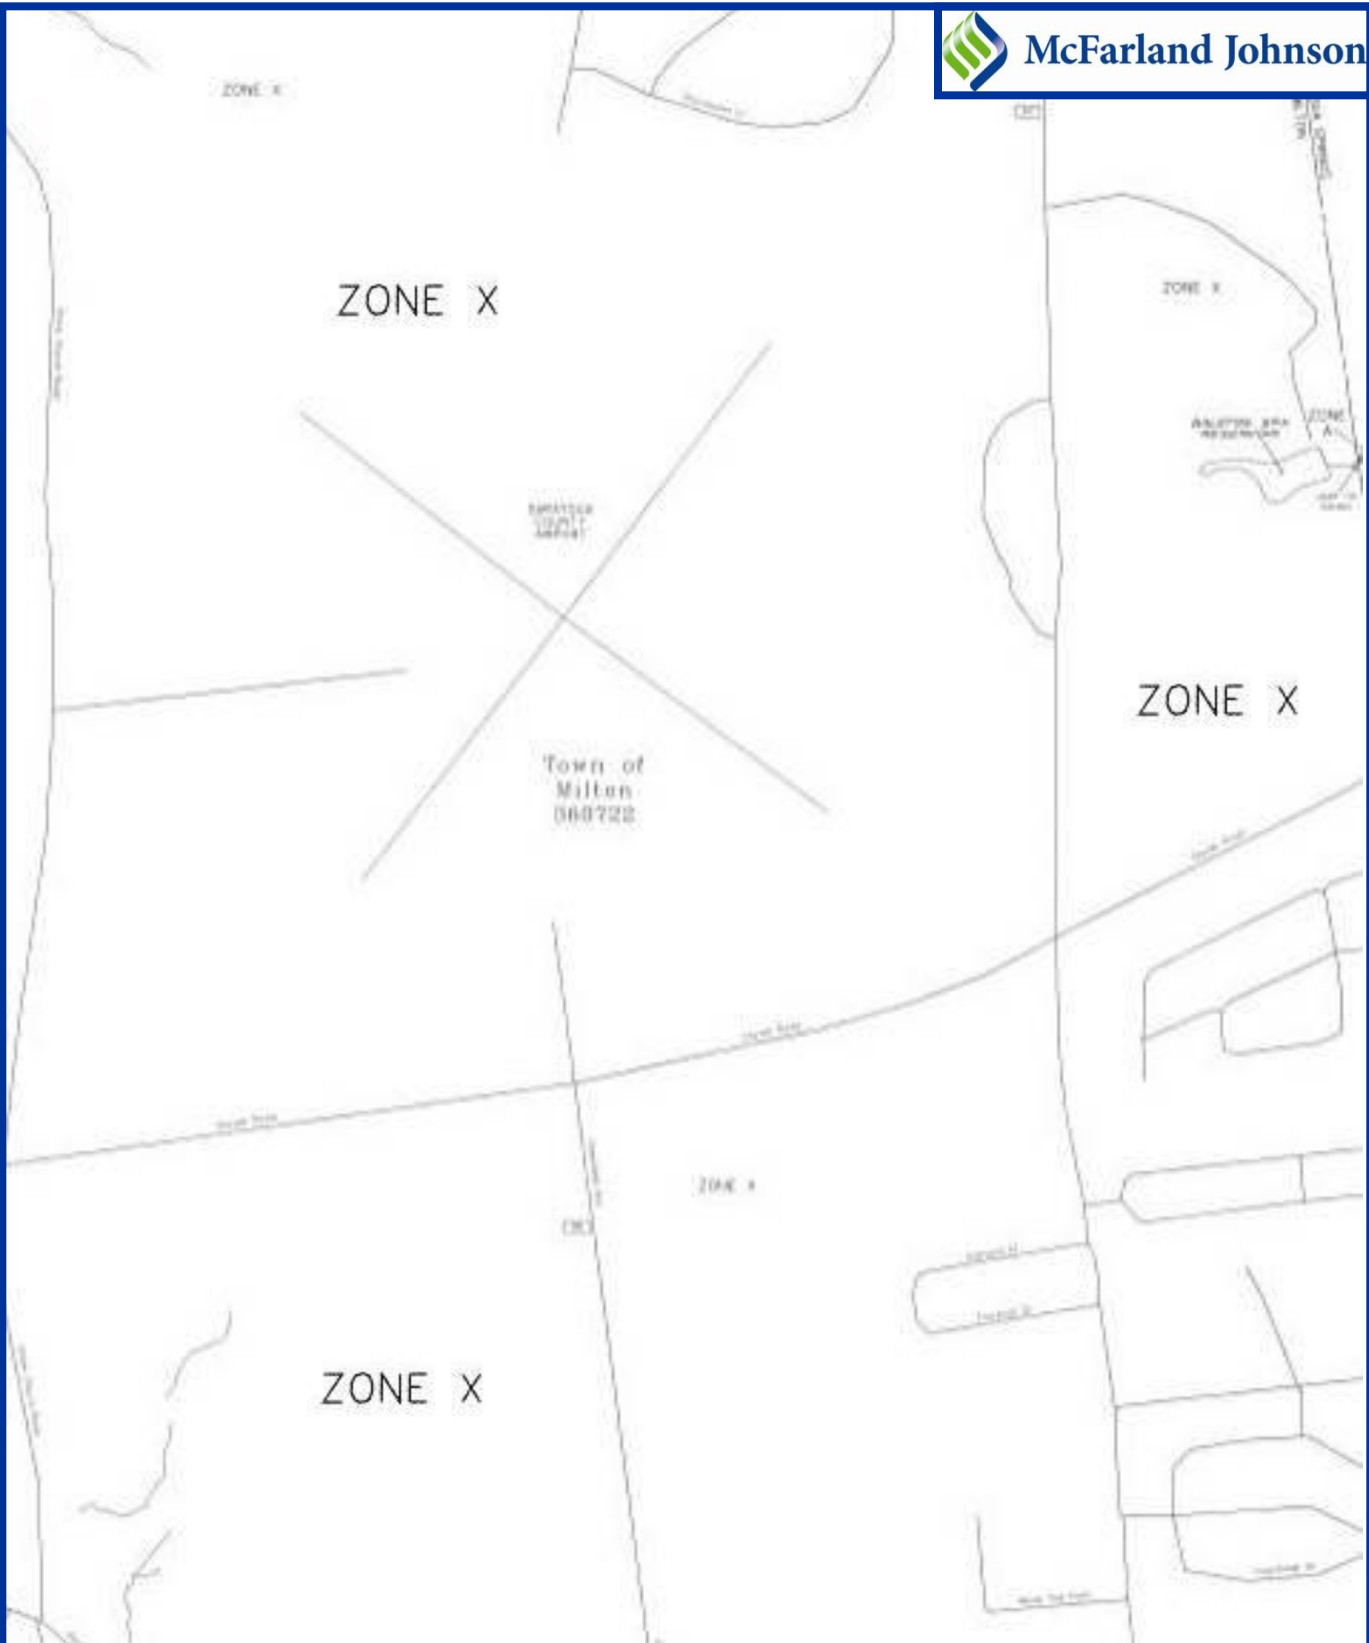
Figure 4

**FEMA Floodplain Map
Saratoga County Airport
Ballston Spa, Saratoga County, New York**
